## SITE INSPECTION ML 47287

Date: June 1, 2006

Lease #: O,G & H, ML 47287

DOGM # M/047/081

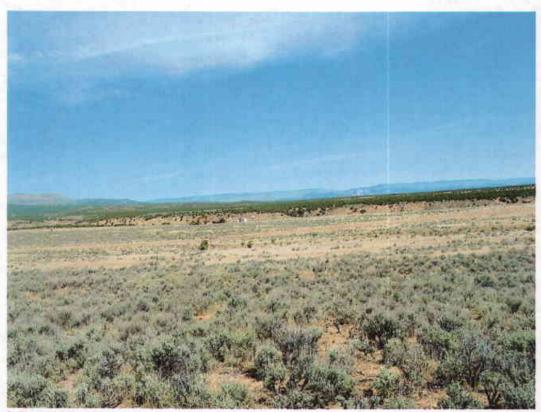
ML 47287, 6-1-06 Looking north from a proposed drill location as identified in the Notice of Intent. In the distance is the processing facility.

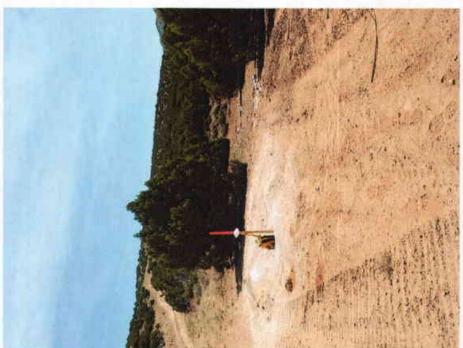
ML 47287, 6-1-06 Looking east onto a drill hole that is identified as "Drill Point # 4" This road is located in the SW¼ of Section 23 and is not shown on the topographic map. The UTM coordinates for this drill hole is: N 4478729.74, E 614415.06. Just west of this location the road has been blocked off with a pile of dirt.

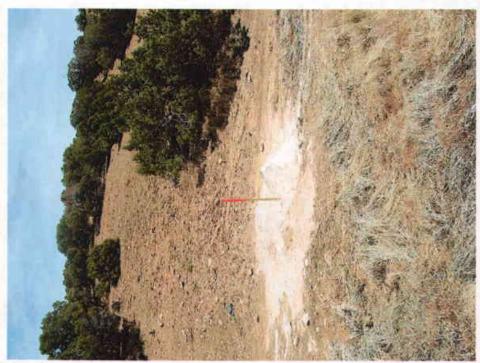
ML 47287, 6-01-06 This drill hole is located in the NW¼NW¼ of Section 26. The lath has no identifying information on it. The UTM coordinates are: N 4478081.14, E 614689.80
